**Flood Control Project Maintenance  
Levee Inspections**

**Fall 2016 Levee Maintenance Deficiency Summary Report**

**Sacramento River Basin**

| <b>RD0010</b> | Overall LMA Rating | Total LMA Miles | * Overall LMA Threshold Percent is less than 10.00%; however, U Rated Miles are present, so the Overall LMA Rating is M instead of A. | | | | | |
|---|---|---|---|---|---|---|---|---|
| <b>Reclamation District No. 0010 Honcut</b> | <b>M *</b> | <b>21.82</b> | | | | | | |

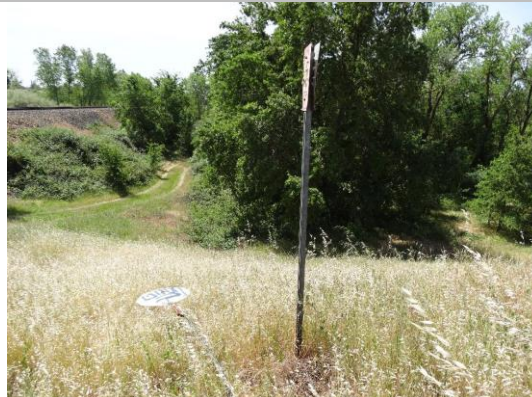
Photo 2 of 2 : UCIP\_FA\_2016\_27791\_51500.jpg

Pipe marker visible on ground--sign has been bent.

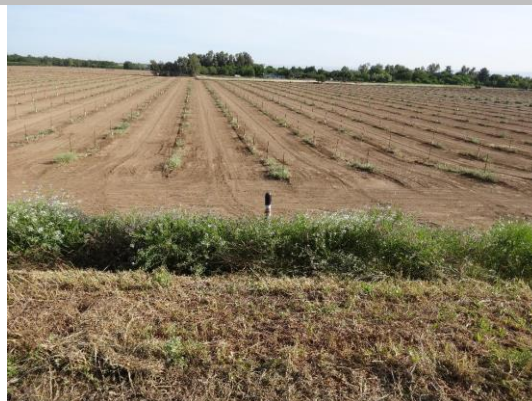
Photo 2 of 2 : UCIP\_FA\_2016\_27712\_51364.jpg

FS\_ID:27712  
DS\_ID:24653  
EP\_NO: N/A  
Repair Type: Non-Urgent  
Crossing Status: Indicator Found  
UCIP Comments: Need to contact owner--unable to determine if crossing is authorized (no permit found) also need to determine if crossing goes through levee.  
FIELD\_STRUCT\_DESC: Fiber optic line markers on levee slope unable to determine if line goes through levee.  
FS Date: 4/29/2013

Marker visible on landward side.

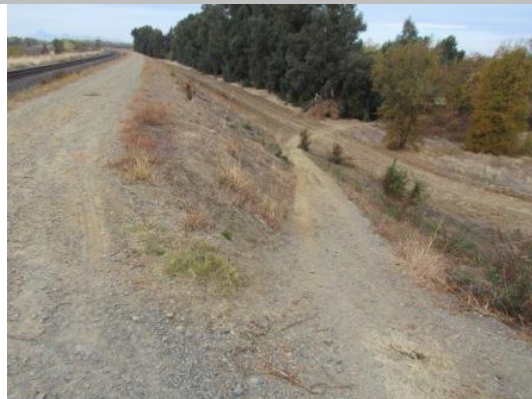
Photo 1 of 2 : FA\_2016\_RD0010\_163\_48\_20160906\_00015.jpg

| Ramp is caused by constant ATV use on levee slope. Fall 2016. | | | | | |

This photo was taken from the crown looking down the landward slope at an ATV access road that has been formed over time to provide access to the waterward side. Fall 2013.

| S3 : Repair the levee slope damaged by vehicle traffic and prevent access where possible. | | | | | |

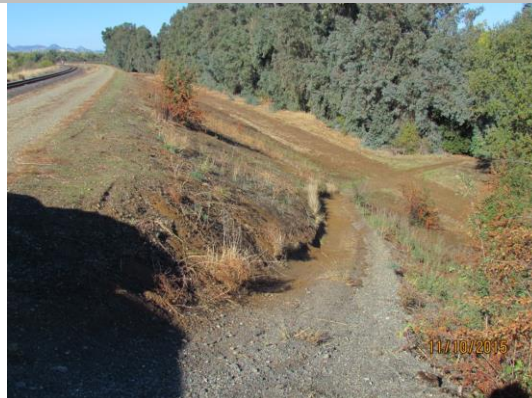
Photo 2 of 2 : FA\_2016\_RD0010\_163\_48\_20160906\_00016.jpg

View of the slope stability on the landward side of the levee looking downstream. Fall 2015.

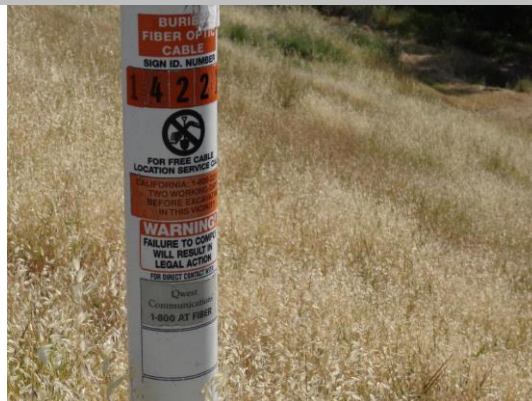
Photo 2 of 2 : UCIP\_FA\_2016\_27715\_51370.jpg

FS\_ID:27715  
DS\_ID:24656  
EP\_NO: N/A  
Repair Type: Non-Urgent  
Crossing Status: Indicator Found  
UCIP Comments: Need to contact owner--unable to determine if crossing is authorized (no permit found) also need to determine if crossing goes through levee.  
FIELD\_STRUCT\_DESC: Fiber optic line markers on levee slope unable to determine if line goes through levee.  
FS Date: 4/29/2013

Contact information and ID number for buried fiber optic cable.

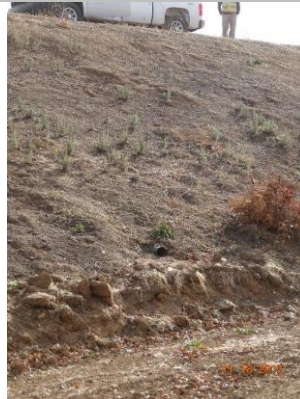
Photo 1 of 1 : UCIP\_FA\_2016\_40545\_51418.jpg

| FS_ID:40545<br>DS_ID:21260<br>EP_NO: 4555<br>Repair Type: Non-Urgent<br>Crossing Status: Indicator Found<br>UCIP Comments: Pipe is approximately 4-6 inches in diameter located near the toe of levee. Crossing is approximately 50 feet downstream of 24-inch pipe. Need to contact owner to determine status of this crossing and to verify the purpose of crossing. If crossing is no longer in use owner will need to contact the CVFPB to comply with Title 23.<br>FIELD_STRUCT_DESC: Abandoned 6-inch steel drainpipe through the levee, 1.0 feet below the crown. Siphon breaker on the waterward shoulder. Pump located at landward toe. Revetment around discharge end of pipe, draining into ditch at waterward toe. Pipe is not buried on berms, gravel pad over pipe across levee crown for vehicular access. Pipe retained through levee under Permit No. 4555 (1964).<br>FS Date: 4/29/2013 | | | | | |

Pipe through levee near waterward toe.

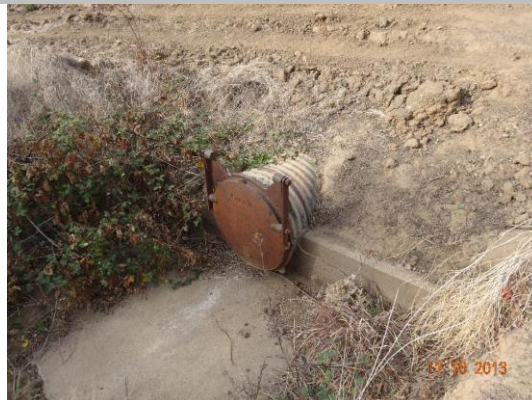
Photo 2 of 2 : UCIP\_FA\_2016\_49986\_44587.jpg

FS\_ID:49986  
DS\_ID:21318  
EP\_NO: N/A  
Repair Type: Urgent  
Crossing Status: Found  
UCIP Comments: 7/01/2016 Pipe wall in poor condition--deteriorated pipe wall indicated by holes at the inlet and outlet pipe collar. Recommend internal integrity inspection of the pipe through the levee to determine extent of damage. (DWR UCIP - omagana)4/29/2013  
Holes present on pipe wall. Need to contact owner to notify of issue with pipe. Also need to contact DWR Inspector and CVFPB to determine how to address issue. This crossing is referenced in the USACE Periodic Inspection as item USACE\_CESPK\_HON1\_2013\_p\_0140. Pipe should be 30-inch instead of 36-inch mentioned Periodic Inspection. (DWR UCIP - omagana)  
FIELD\_STRUCT\_DESC: 30-inch corrugated metal drainage pipe through the levee, approximately 30 feet below the crown. Two CM cutoff walls around the pipe on both sides. Saddle and splash apron are located on the waterside (WS) discharge point. Concrete headwall and sluice gate are located on the landside (LS). [Additional Reference(s): DWR Levee Log, 2005. USACE Sacramento O&M Manual Unit No. 151, May 1953, Station 10+38].

View of headwall, pipe, and flap gate located on WS.

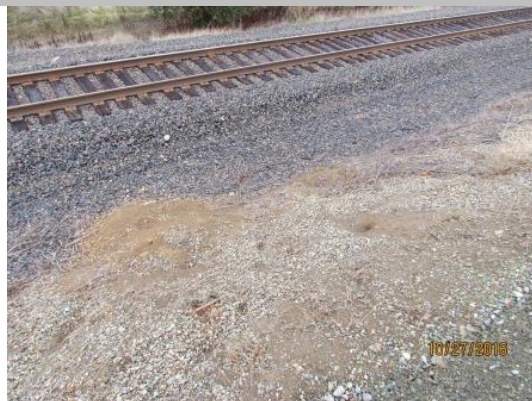
Photo 1 of 1 : FA\_2016\_RD0010\_163\_65\_20161031\_00074.jpg

View of squirrel holes on the landside, no rodent activity was observed. Fall 2016.

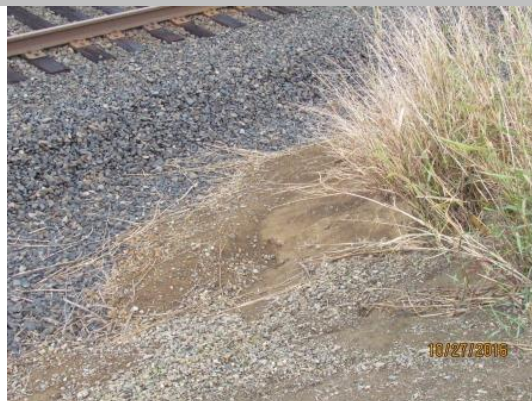
Photo 1 of 1 : FA\_2016\_RD0010\_163\_64\_20161031\_00075.jpg

View of squirrel holes on the landside, no rodent activity was observed. Fall 2016.

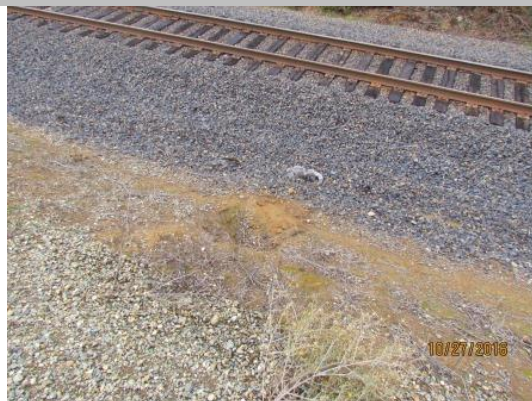
Photo 1 of 1 : FA\_2016\_RD0010\_163\_63\_20161031\_00076.jpg

View of squirrel holes on the landside, no rodent activity was observed. Fall 2016.

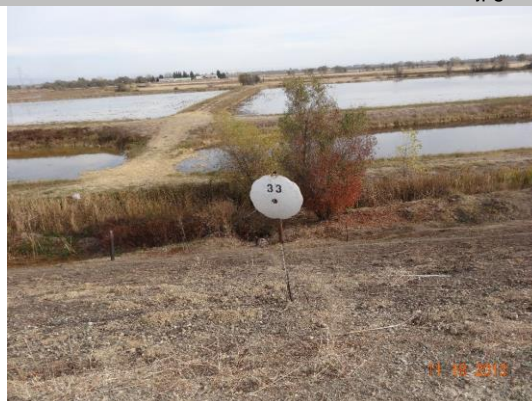
Photo 1 of 2 : UCIP\_FA\_2016\_27745\_51429.jpg

| FS_ID:27745<br>DS_ID:21271<br>EP_NO: N/A<br>Repair Type: Non-Urgent<br>Crossing Status: Found<br>UCIP Comments: Unable to determine if crossing is still present on landward side--need to confirm. Need to contact owner to determine status of crossing. This crossing is referenced in the USACE Periodic Inspection as item USACE_CESPK_HON1_2013_p_0185.<br>FIELD_STRUCT_DESC: 24-inch pipe through the levee, 30.0 feet below the crown. Flap gate on waterward end. Concrete headwall at both toes.<br>FS Date: 4/29/2013 | | | | | | |

View of waterward side--marker indicating crossing visible on waterward shoulder.

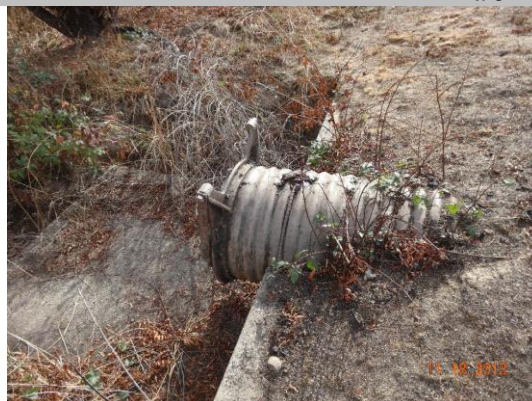
Photo 2 of 2 : UCIP\_FA\_2016\_27745\_51432.jpg

View of pipe, headwall, and flap gate located on waterward side.

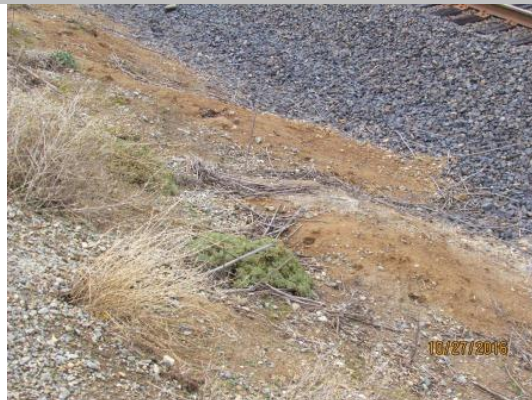
Photo 1 of 1 : FA\_2016\_RD0010\_163\_61\_20161031\_00077.jpg

View of squirrel holes on the landside slope and toe, no rodent activity was observed. Fall 2016.

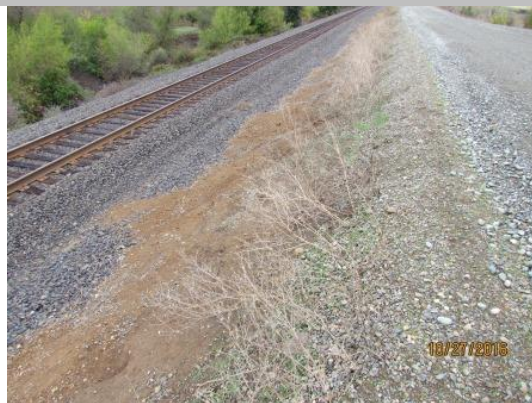
Photo 1 of 1 : FA\_2016\_RD0010\_163\_60\_20161031\_00078.jpg

View of squirrel holes on the landside slope and toe, no rodent activity was observed. Fall 2016.

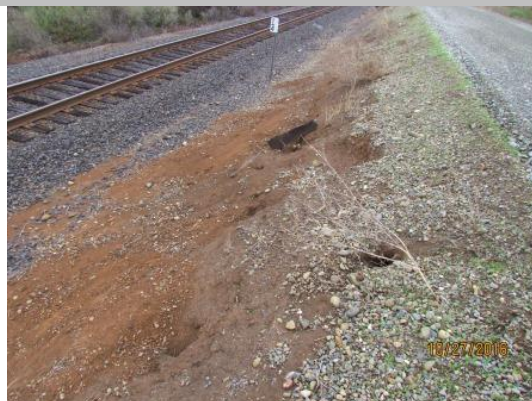
Photo 1 of 1 : FA\_2016\_RD0010\_163\_57\_20161031\_00081.jpg

View of squirrel holes on the landside slope and toe, no rodent activity was observed. Fall 2016.

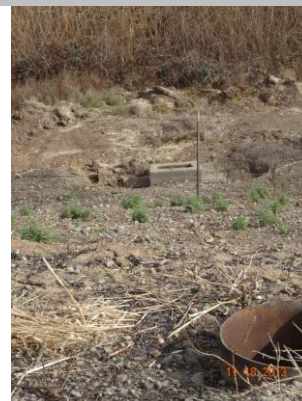
Photo 1 of 2 : UCIP\_FA\_2016\_49987\_44608.jpg

| FS_ID:49987<br>DS_ID:21272<br>EP_NO: 14020<br>Repair Type: Urgent<br>Crossing Status: Indicator Found<br>UCIP Comments: 7/01/2016 Dense vegetation--unable to determine if the sink hole/slope depression noted back in Jan 2013 in the USACE's PI Report is still present. Need to revisit the site once vegetation from the slopes has been cleared. (DWR UCIP - omagana)4/29/2013<br>Unable to determine status of crossing--sink hole was observed as part of the USACE Periodic Inspection Report dated May 2013. Need to coordinate with owner to determine status of crossing. If crossing is no longer in use owner will need to contact the CVFPB to comply with Title 23. Need to confirm with Finney to determine if pump and controls belong to pipe crossing located on landward side. This crossing is referenced in the USACE Periodic Inspection as item USACE_CESPK_HON1_2013_p_0192. (DWR UCIP - omagana)<br>FIELD_STRUCT_DESC: 10-inch steel drainage pipe sleeved through a 16-inch steel pipe, 5 feet below the crown. Annular gap between 10-inch and 16-inch pipes has been grouted. Concrete cutoff wall around pipe is located at the center of levee. Siphon breaker is located on the waterside (WS) shoulder. Flap gate and concrete headwall are located on the WS toe. Pump is located on the landside (LS). This drainage pipe is used to divert water from the drainage ponds, that serves the residential development located on the LS, to the Jack Slough. (Permit No. 14020, 1986 - California North Lands, Inc.) [Additional Reference(s): DWR Levee Log, 2005].<br>FS Date: 7/1/2016 | | | | | |

View of WS--concrete box located located at WS toe.

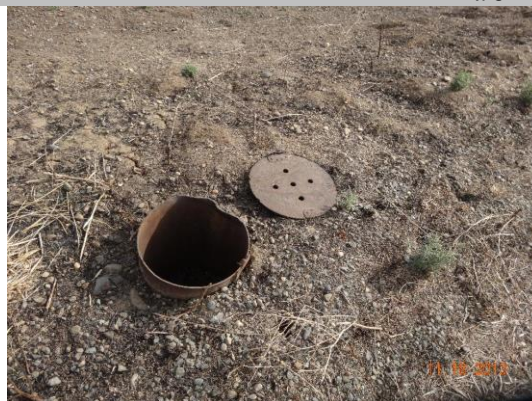
Photo 2 of 2 : UCIP\_FA\_2016\_49987\_44605.jpg

View of riser with damage lid located on WS shoulder.

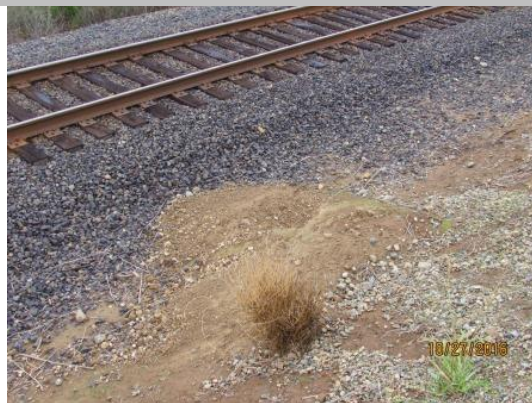
Photo 1 of 1 : FA\_2016\_RD0010\_163\_52\_20161031\_00085.jpg

View of squirrel holes on the landside slope and toe, no rodent activity was observed. Fall 2016.

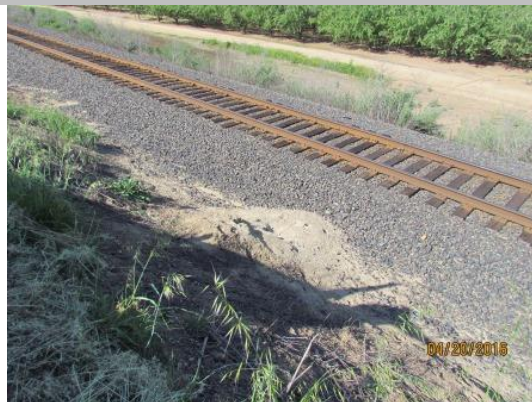
Photo 1 of 1 : FA\_2016\_RD0010\_163\_51\_20160906\_00017.jpg

View of large burrow on landside.

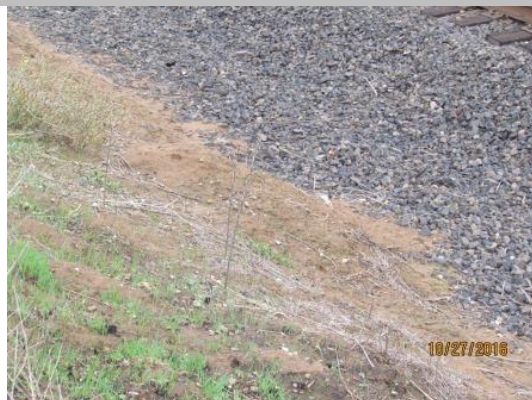
Photo 1 of 1 : FA\_2016\_RD0010\_163\_46\_20161031\_00089.jpg

View of squirrel holes on the landside slope and toe, no rodent activity was observed. Fall 2016.

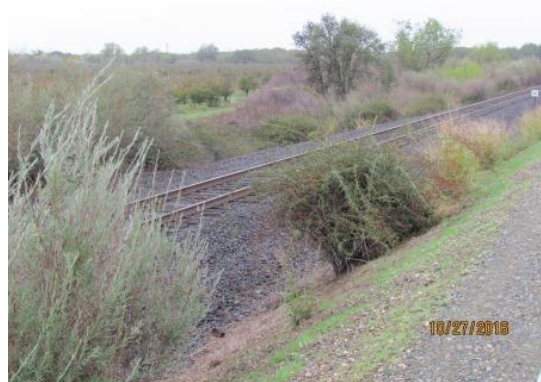
Photo 1 of 1 : FA\_2016\_RD0010\_163\_45\_20161031\_00090.jpg

View of wild rosebush on the landside levee slope looking upstream. Fall 2016.

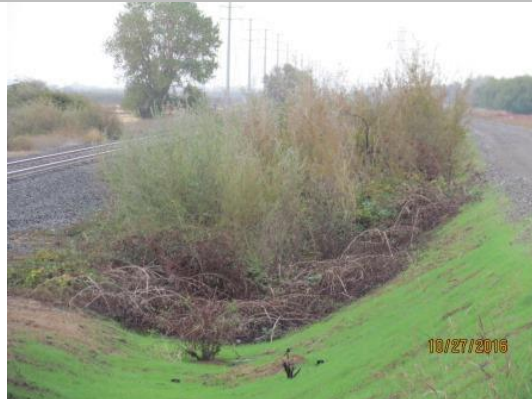
Photo 2 of 2 : FA\_2016\_RD0010\_163\_36\_20161031\_00093.jpg

View looking upstream landside of willows and wild rosebushes that are blocking visibility at the toe. Fall 2016.

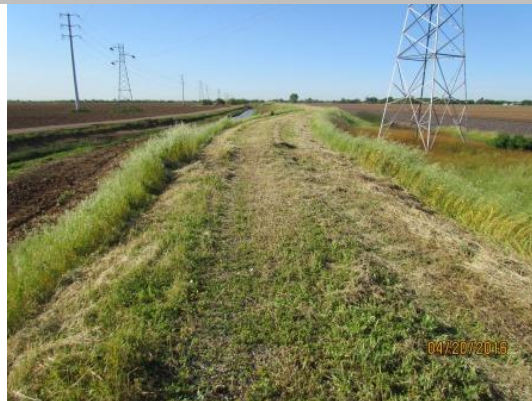
Photo 3 of 4 : FA\_2016\_RD0010\_163\_27\_20160906\_00006.jpg

View of depression in crown, caused by an unpermitted pipe crossing. A FIR was created for this issue. Spring 2016.

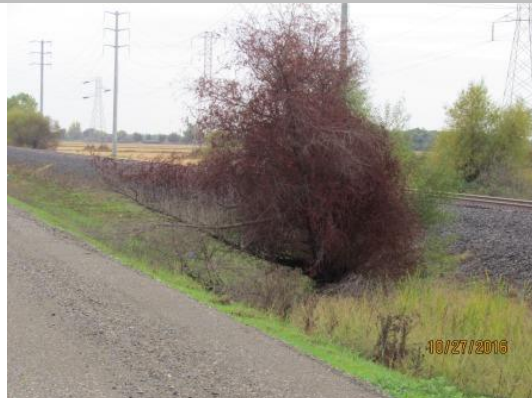
Photo 2 of 2 : FA\_2016\_RD0010\_163\_32\_20161031\_00096.jpg

View of a tree that needs to be removed on the landside, looking downstream. Fall 2016.

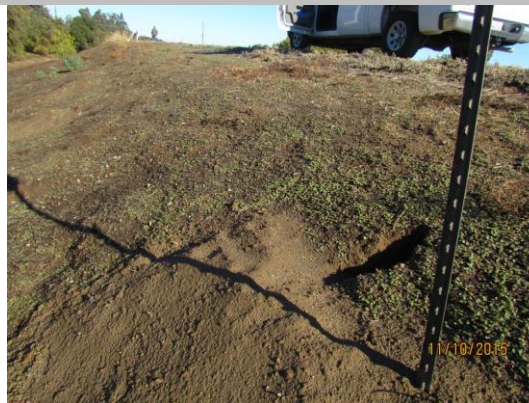
Photo 1 of 2 : FA\_2016\_RD0010\_164\_28\_20160906\_00007.jpg

View of the rodent hole on the waterward side of the levee looking upstream. Fall 2015.

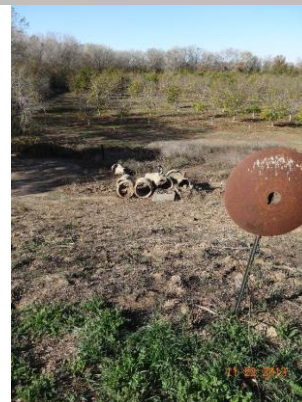
Photo 2 of 2 : UCIP\_FA\_2016\_24824\_44657.jpg

Overview of waterward slope--barrier placed at toe to discourage damage to crossing.

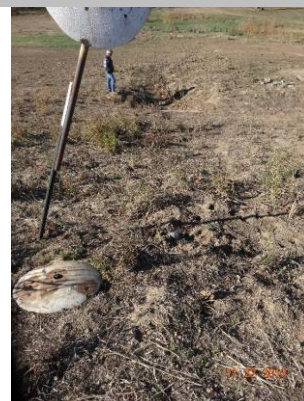
Photo 2 of 2 : UCIP\_FA\_2016\_24825\_44663.jpg

View of waterward slope--burrow activity present.

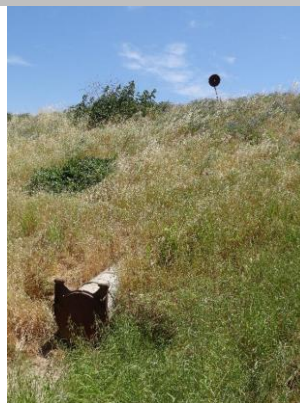
Photo 1 of 2 : UCIP\_FA\_2016\_24751\_44375.jpg

View of waterward side--dense vegetation on slope.

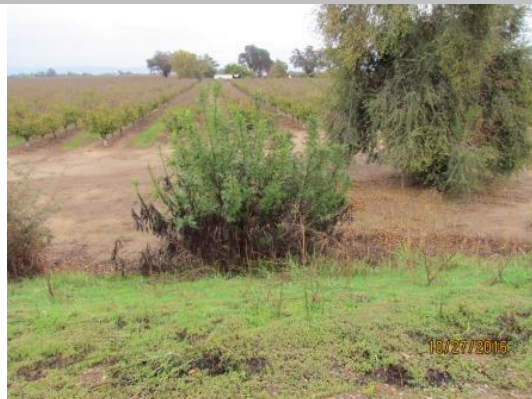
Photo 1 of 1 : FA\_2016\_RD0010\_164\_47\_20161031\_00088.jpg

View of a small tree at the toe of the landside. Fall 2016.

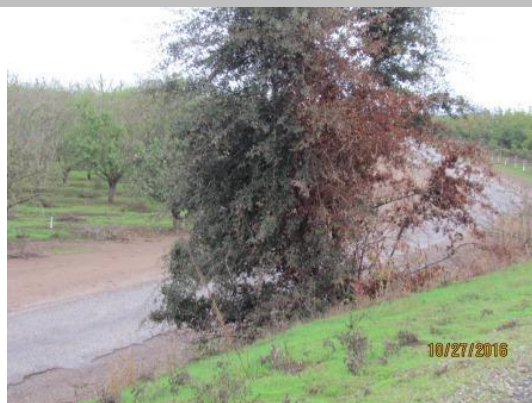
Photo 1 of 1 : FA\_2016\_RD0010\_164\_59\_20161102\_00104.jpg

View of a tree on landside looking downstream that needs to be trimmed up 5' for access and visibility. Fall 2016.

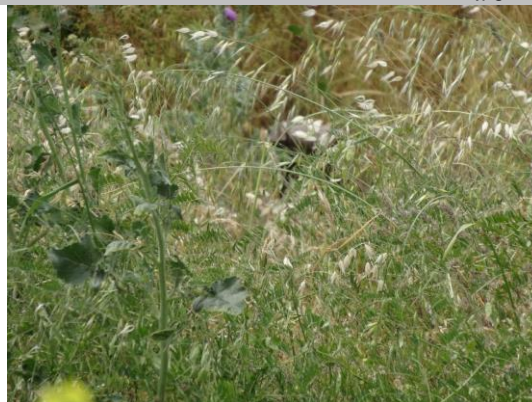
Photo 2 of 2 : UCIP\_FA\_2016\_24768\_44451.jpg

Dense vegetation on landward side.

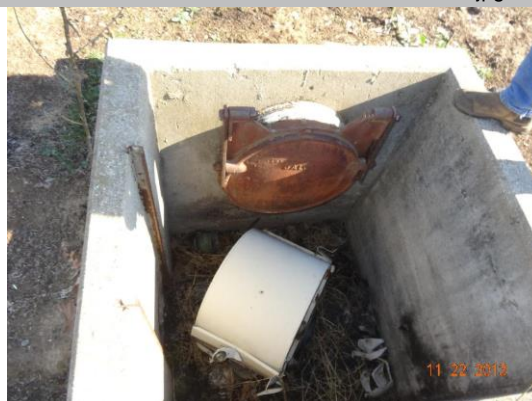
Photo 2 of 2 : UCIP\_FA\_2016\_24769\_44453.jpg

View of flap gate located inside concrete distribution box. Debris scattered inside box.

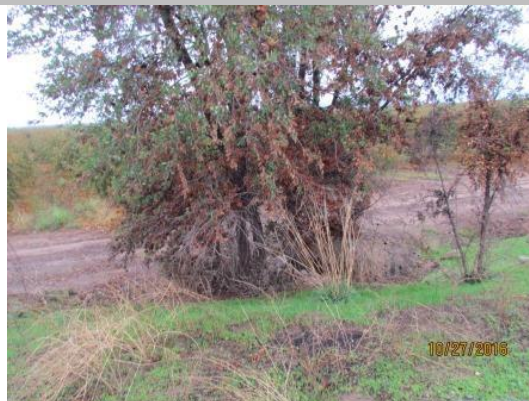
Photo 1 of 1 : FA\_2016\_RD0010\_164\_70\_20161103\_00114.jpg

View of tree on landside toe that need to be trimmed up five feet for visibility and access. Fall 2016.

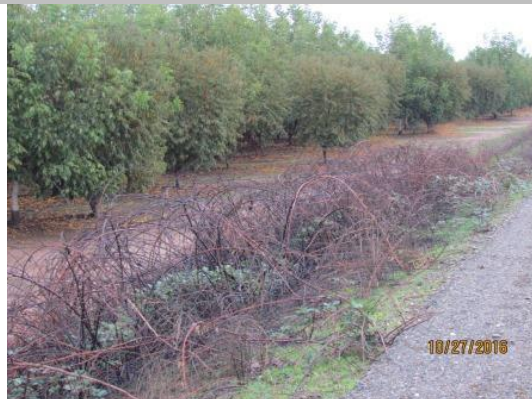
Photo 1 of 1 : FA\_2016\_RD0010\_164\_73\_20161103\_00117.jpg

View of landside slope looking downstream where blackberry bushes have been sprayed and burned but need to be removed. Fall 2016.

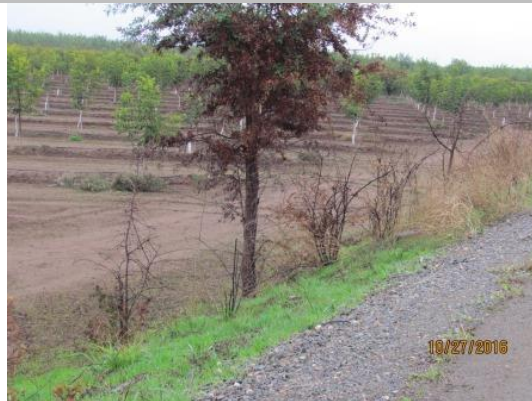
Photo 1 of 1 : FA\_2016\_RD0010\_164\_75\_20161103\_00118.jpg

View of landside looking downstream where the tree has been trimmed up but small starter trees should be removed. Fall 2016.

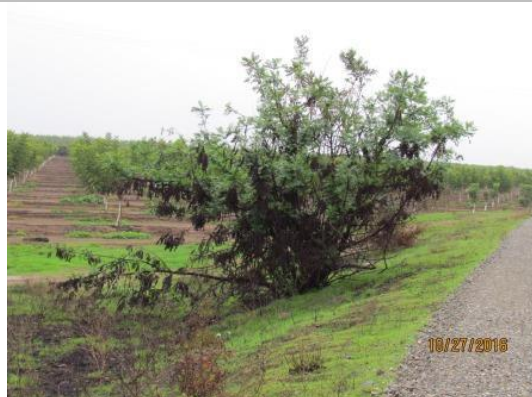
Photo 1 of 1 : FA\_2016\_RD0010\_164\_77\_20161103\_00120.jpg

View looking downstream of a small tree on landside slope that should be removed. Fall 2016.

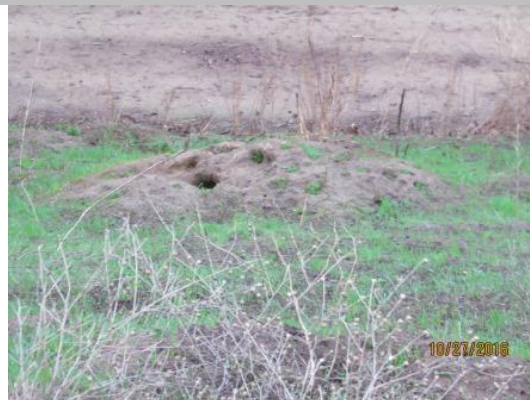
Photo 1 of 1 : FA\_2016\_RD0010\_165\_6\_20161103\_00015.jpg

View of waterside slope, no squirrel activity seen, but rodent holes need to be back filled properly. Fall 2016.

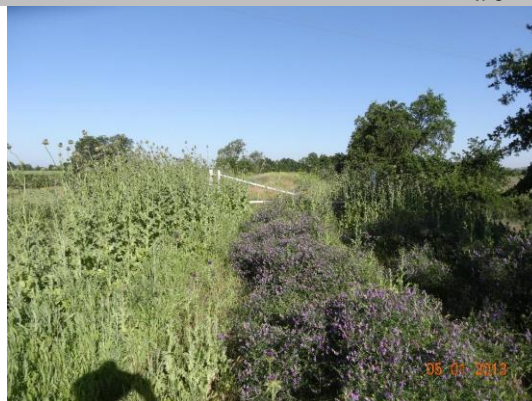
Photo 2 of 2 : UCIP\_FA\_2016\_24883\_44821.jpg

View of levee crown--dense vegetation.
